522 Russell Street

Sunday, January 27, 2019

Inspected *by* Barry Mankin

Prepared *for* John And Jane Doe

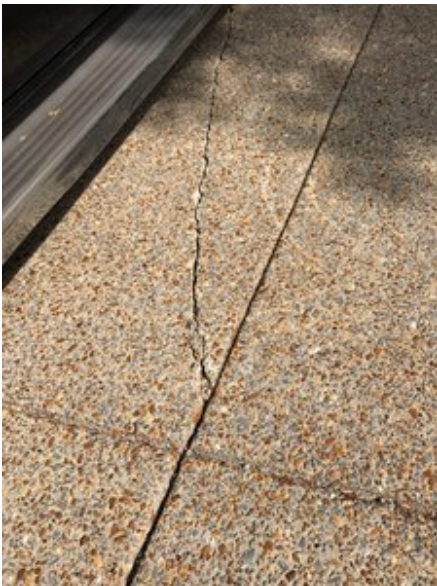
② DRIVEWAY

Common cracks and settlement were observed. Sealant is recommended on the driveway as part of normal maintenance.

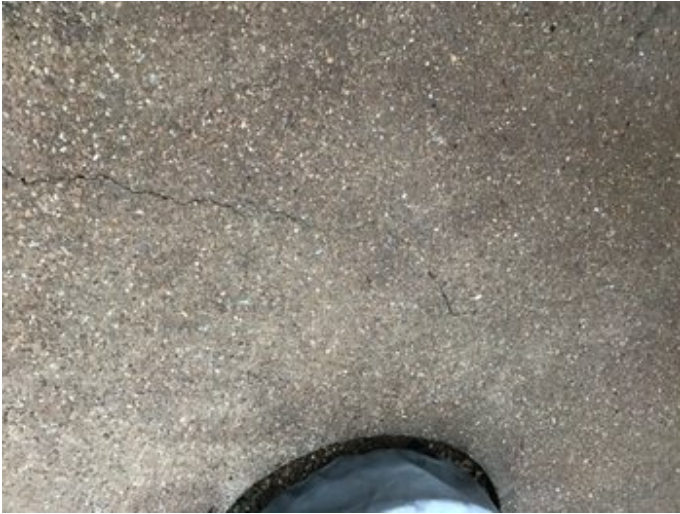
② SIDEWALKS/WALKWAYS

Common cracks observed.

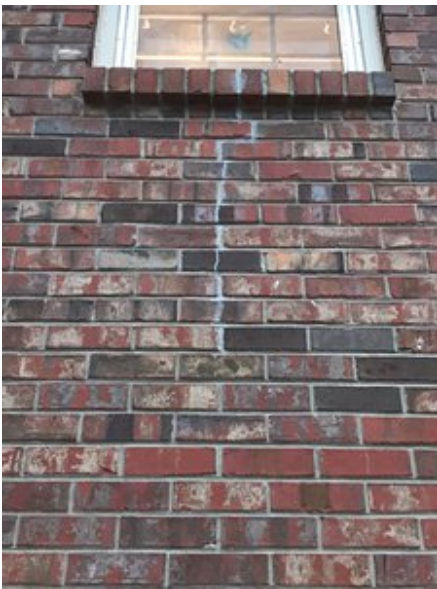
🛡️ EXTERIOR WALL CONDITIONS

Patched settlement crack visible. Recommend monitoring. No evidence of recent movement.

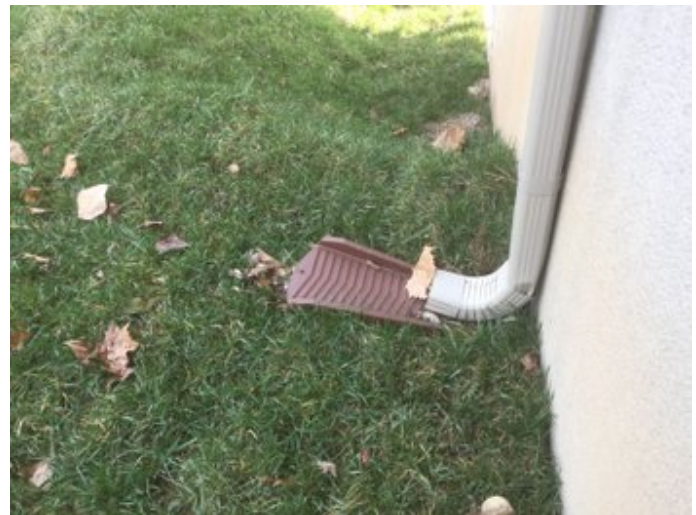
GUTTERS

Recommend gutter downspouts be extended and routed away from the building at least 4-6ft. for proper drainage. Water seepage into crawl spaces, basements and under foundations can be caused by inadequate removal of rainwater from the perimeter of the house.

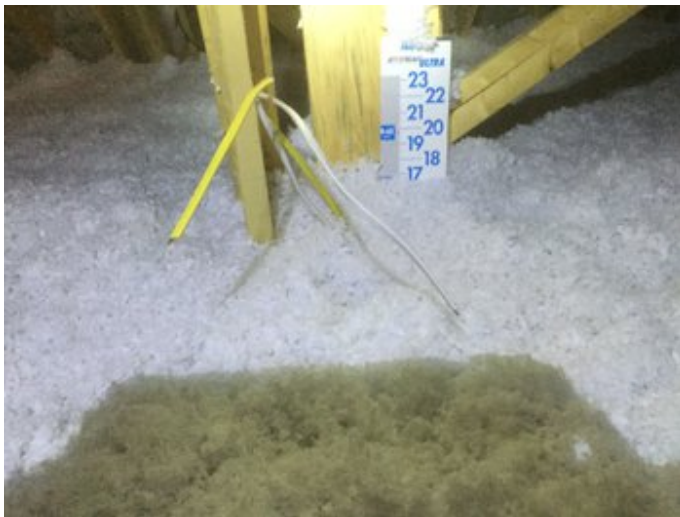
⚠ ATTIC CONDITIONS

Open Junction Boxes in the Attic.

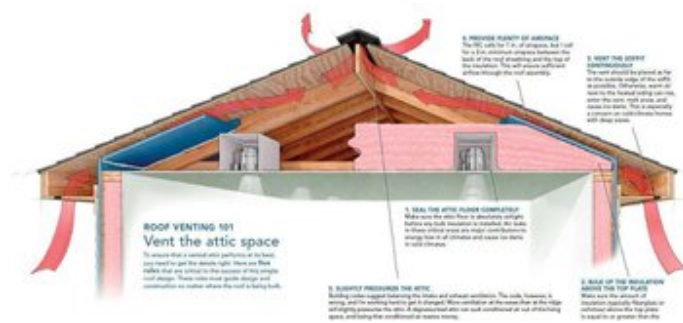
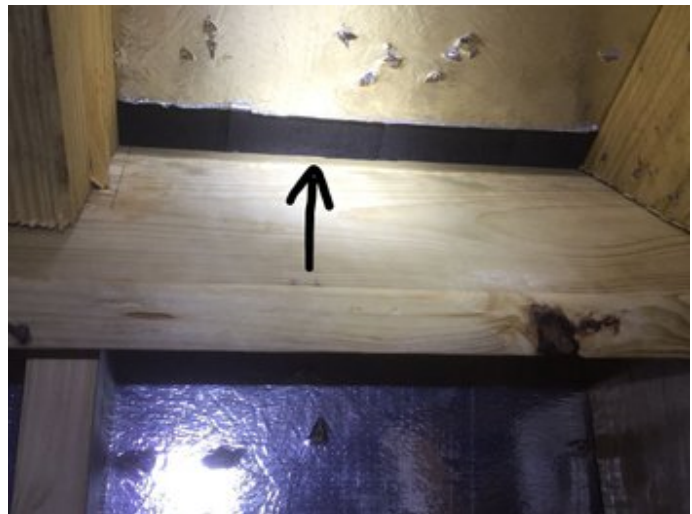
⚠ ATTIC CONDITIONS

The vents were blocked at the time of the inspection. This restricts proper air movement. Recommend provisions be made for proper ventilation.

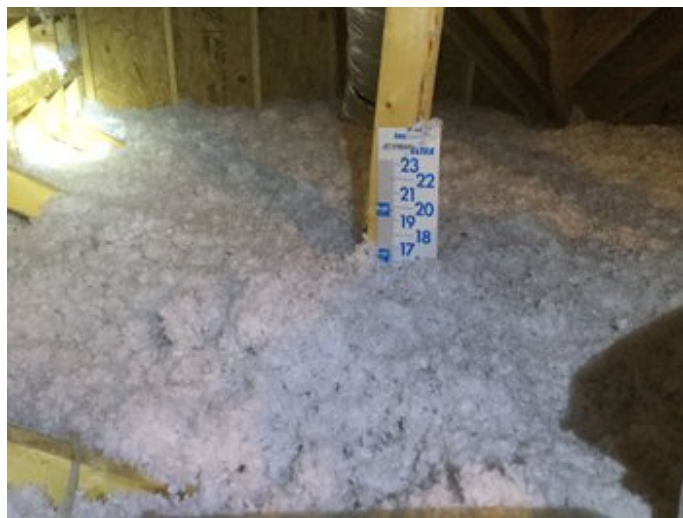
ATTIC INSULATION CONDITIONS

The attic has blown-in insulation. The approximate depth of the insulation is 10+ inches, which appears adequate.

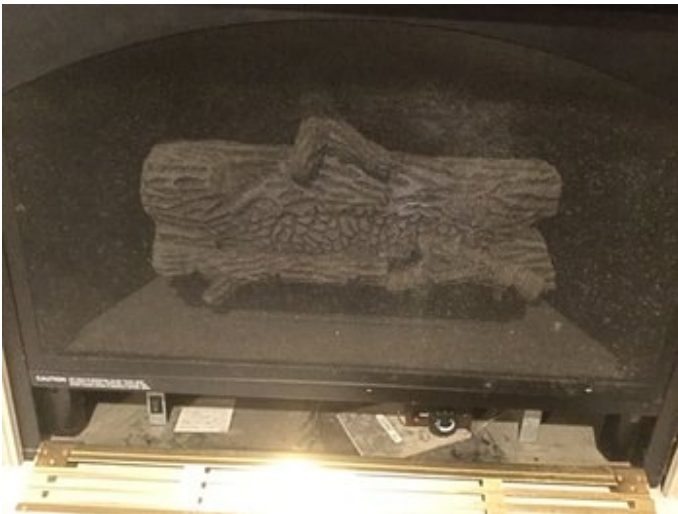
🚫 FIREPLACE/CHIMNEY CONDITIONS

Damper operation for fireplace was not adapted for gas.....recommend certified chimney expert evaluate and update for safety. Carbon monoxide must be able to escape with a pilot.

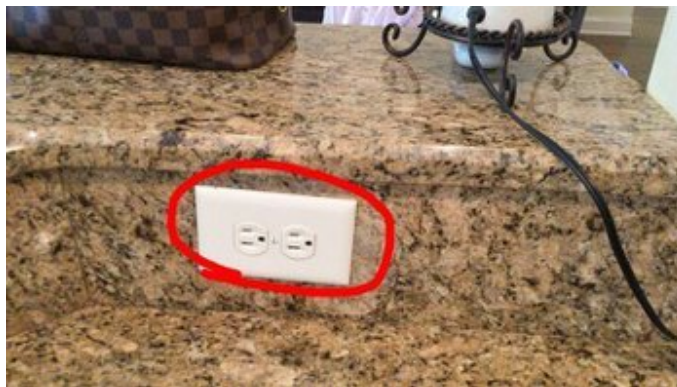
⚠ ELECTRICAL CONDITIONS

- ☑ Loose
- ☑ Kitchen
- ☑ No GFCI protection.

For Safety add a GFCI outlet or GFCI breaker to any location with water less than 6ft between the outlet and water. (Exterior, Bar sink, Basement, Garage, Kitchen, Laundry and Bath).

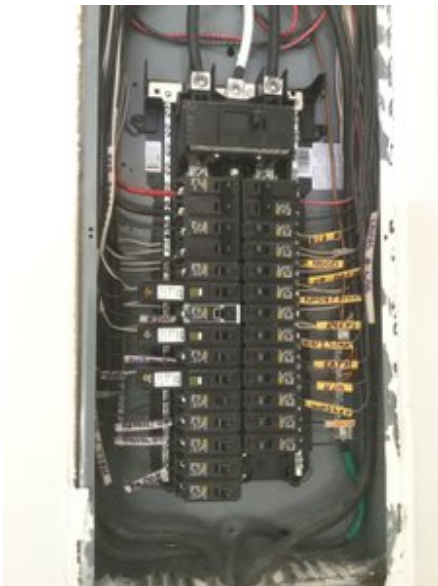
⊜ ELECTRICAL PANEL CONDITIONS

The visible and accessible areas of the panel look to be in serviceable condition at the time of the inspection.

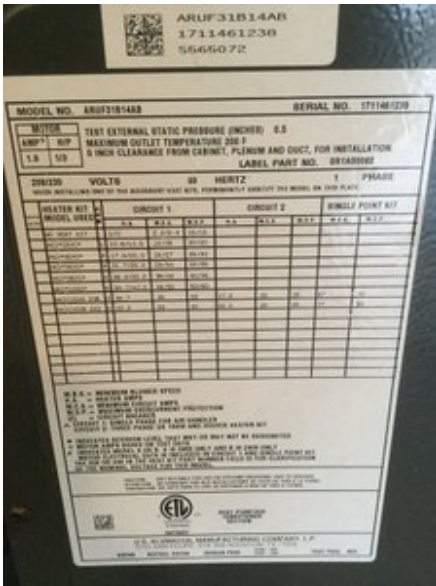
ⓘ A/C BTU RATING

Not inspected due to temperatures under 60 deg within a 24 hr period

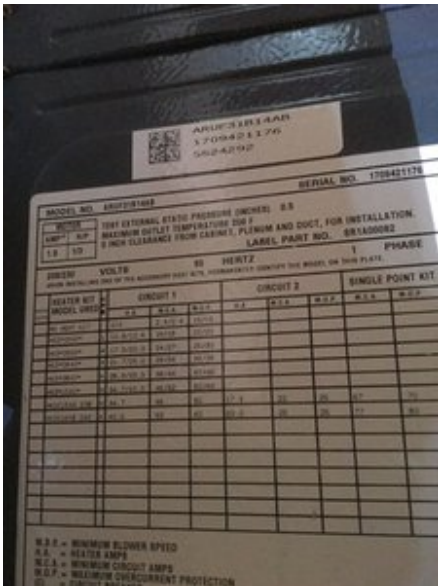
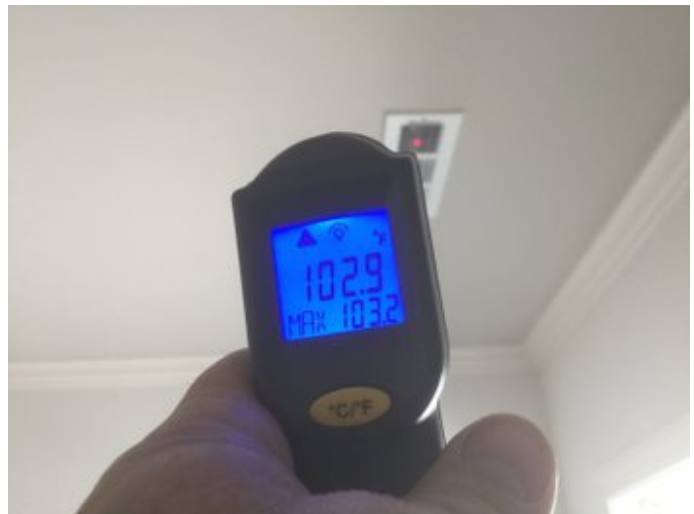
ⓘ UNIT CONDITIONS

The Heating system was working at the time of inspection. Recommend bi-annual maintenance on the HVAC system. Over 20 deg differential.

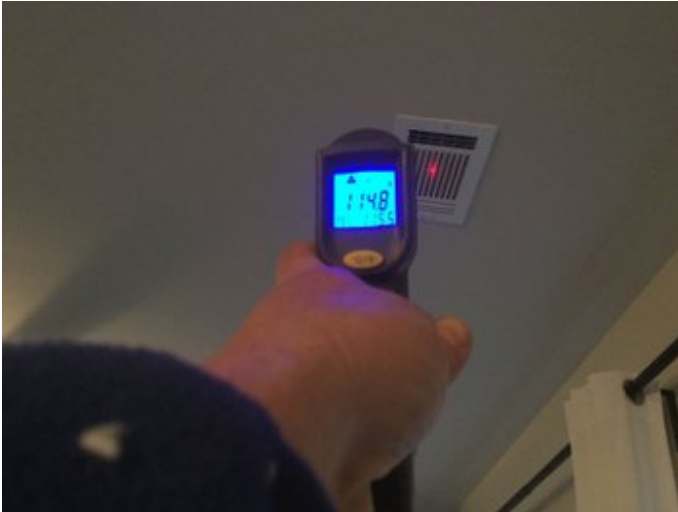
UNIT CONDITIONS
Satisfactory

The Heating system was working at the time of inspection. Recommend bi-annual maintenance on the HVAC system. Over 20 deg differential.

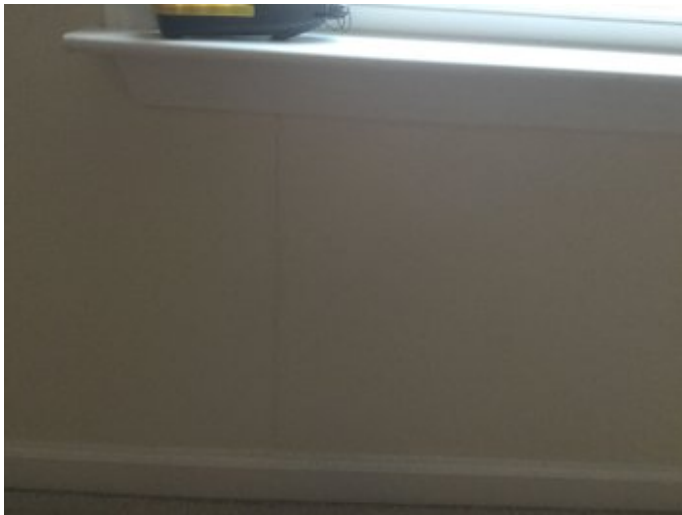
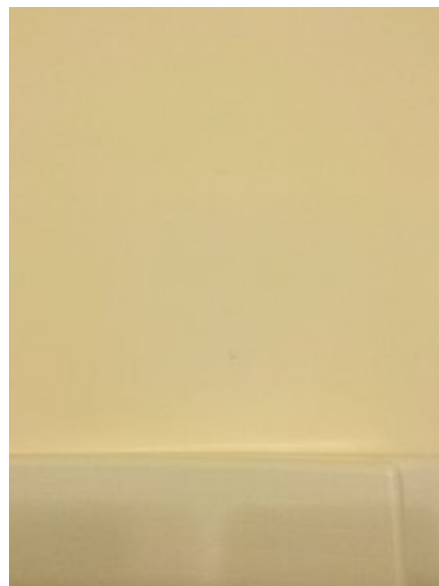
🛡️ WALL CONDITIONS

Drywall cracking viewed. Nail pops.

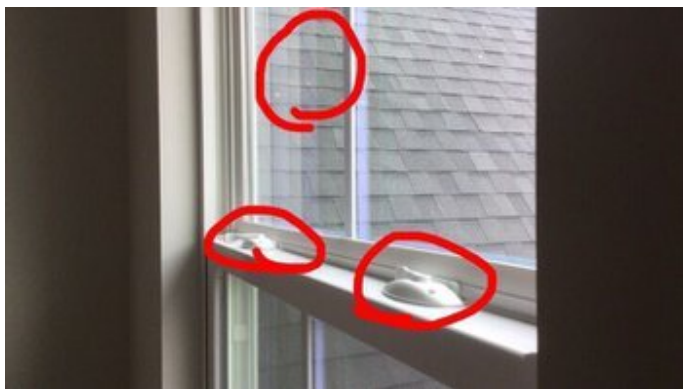
ⓘ WINDOW CONDITIONS

Some locks were missing or broken. For security reasons, recommend locks be repaired.

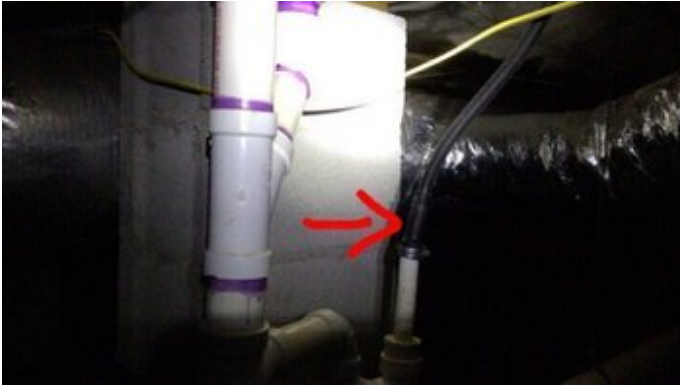
ⓘ DISHWASHER CONDITIONS

The dishwasher was operational at the time of inspection. Improper plumbing installation under dishwasher in crawlspace. Recommend certified plumber evaluate and repair.

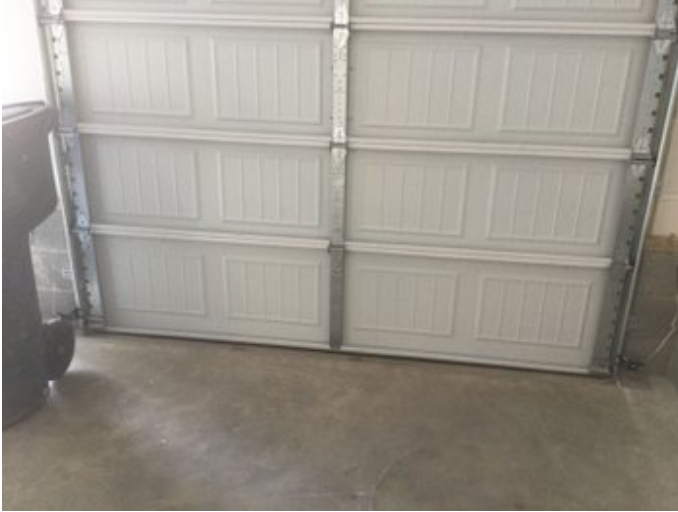
🔒 VEHICLE DOOR CONDITIONS

Recommend insulation panels on garage doors due to plumbing access in the garage. This would be an update.

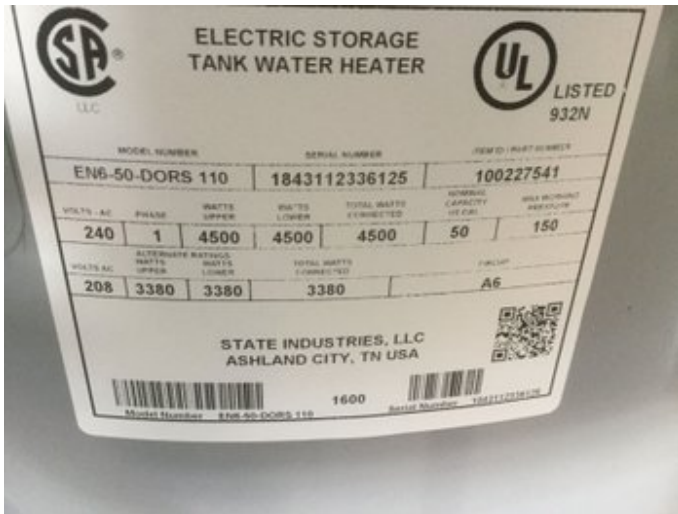
ⓘ WATER HEATER CAPACITY

50 Gallon

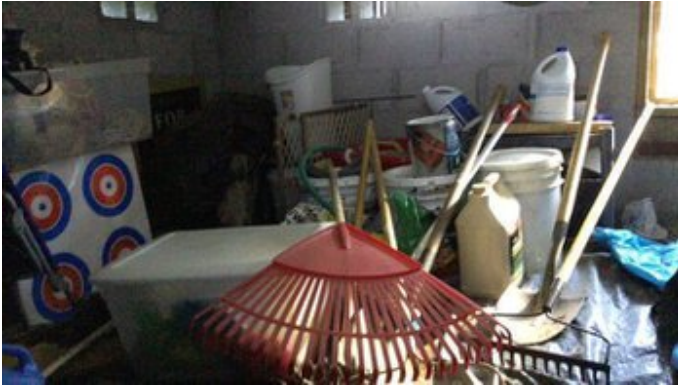
📍 CRAWLSPACE CONDITIONS

Some areas of crawlspace had personal items being stored. Areas behind personal items were not visible.

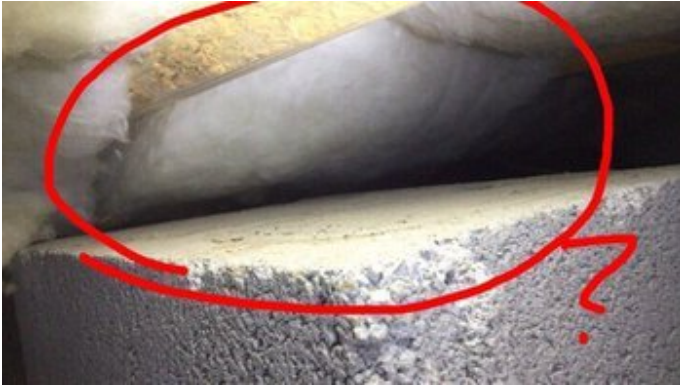
📍 CRAWLSPACE CONDITIONS

Support column in the center of the home was not shimmed. Recommend certified contractor evaluate gap and shim appropriately for support.

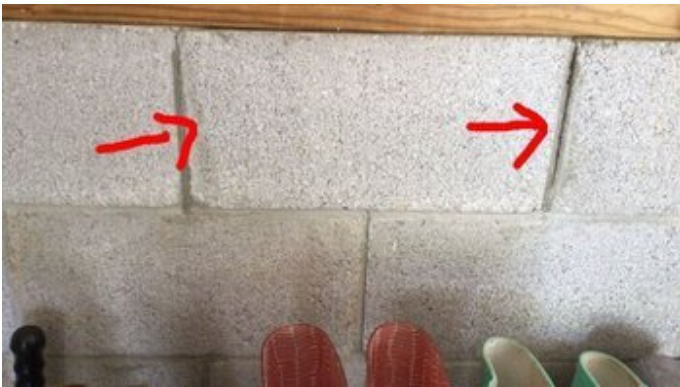
🏠 CRAWLSPACE CONDITIONS

Slight step cracking visible in Foundation. Recommend monitoring.

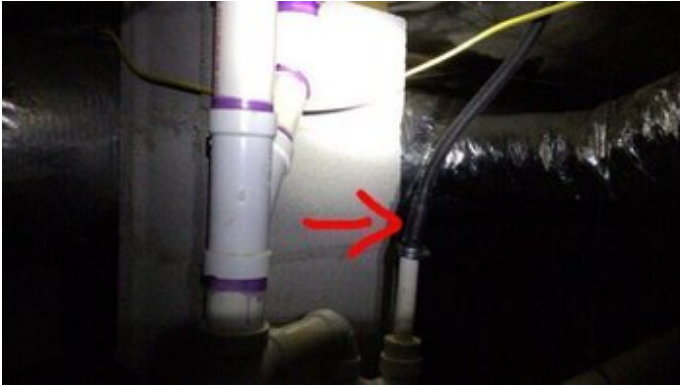
⊞ DRAIN LINE CONDITIONS

Drain line under kitchen sink as a relates to dishwasher to be evaluated and repaired.
